**Eagle Lake Baseline and Two Year Post-LFA
Data Report
2016-2018
Kalamazoo County, Michigan**

**Prepared by: Restorative Lake Sciences
Jennifer L. Jermalowicz-Jones, PhD
Water Resources Director
18406 West Spring Lake Road
Spring Lake, Michigan 49456
www.restorativelakesciences.com**

December 3, 2018

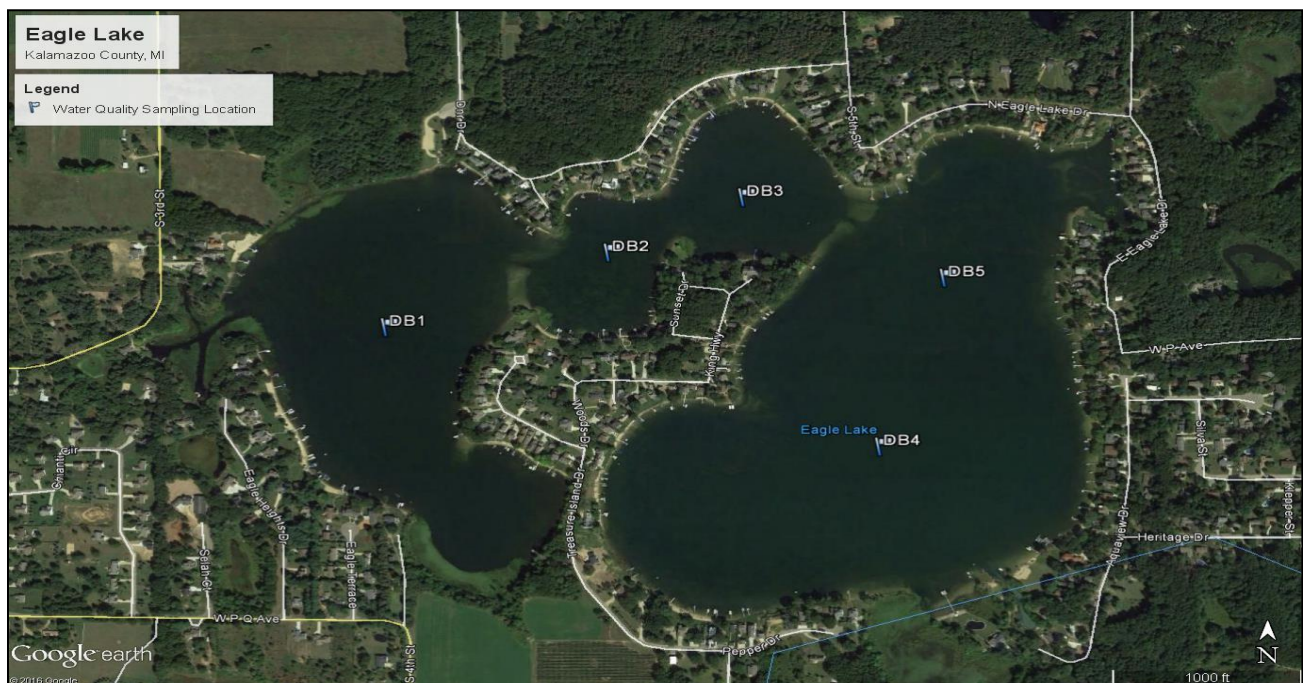
Figure 1. 2016-2018 water quality sampling locations on Eagle Lake, Kalamazoo County, MI.

Aquatic vegetation survey was conducted on May 13, 2016 and again on September 15, 2016 and on May 10, 2017, and on May 30, 2018. All water quality samples in 2016-2018 were collected from the sampling locations according to Figure 1. Sediment muck depths in 2016-2017 were collected from the sampling locations according to Figure 2.

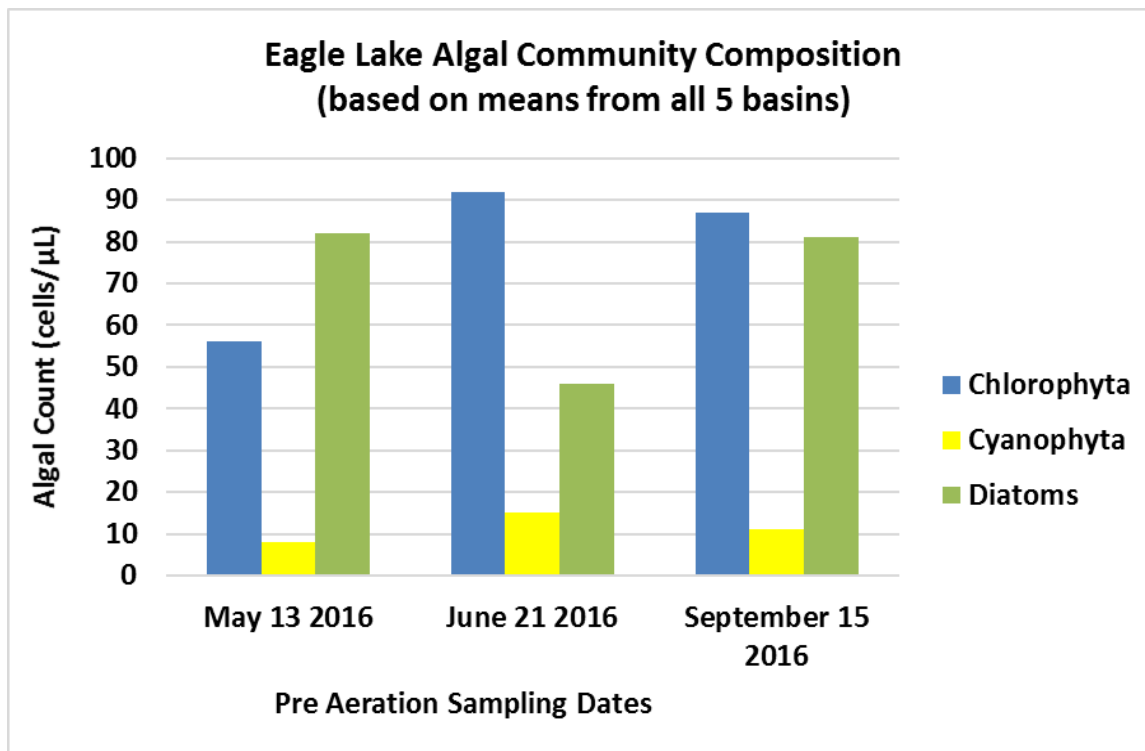
Algal community composition data were collected during the 3 sampling periods at each of the 5 basins in 2016. Means of the taxa were placed in the graph (Figure 4) below. Genera are listed here in the order of most abundant to least abundant. The genera present included the Chlorophyta (green algae): *Scenedesmus* sp., *Chlorella* sp., *Haematococcus* sp., *Rhizoclonium* sp., *Mougeotia* sp., *Ulothrix* sp., *Pandorina* sp., *Pediastrum* sp., *Spirogyra* sp., *Euglena* sp., and *Chloromonas* sp. the Cyanophyta (blue-green algae): *Oscillatoria* sp.; the Bascillariophyta (diatoms): *Navicula* sp., *Fragilaria* sp., *Synedra* sp., *Tabellaria* sp., and *Rhoicosphenia* sp.

Figure 4. Baseline relative abundance of algal taxa in Eagle Lake (2016).

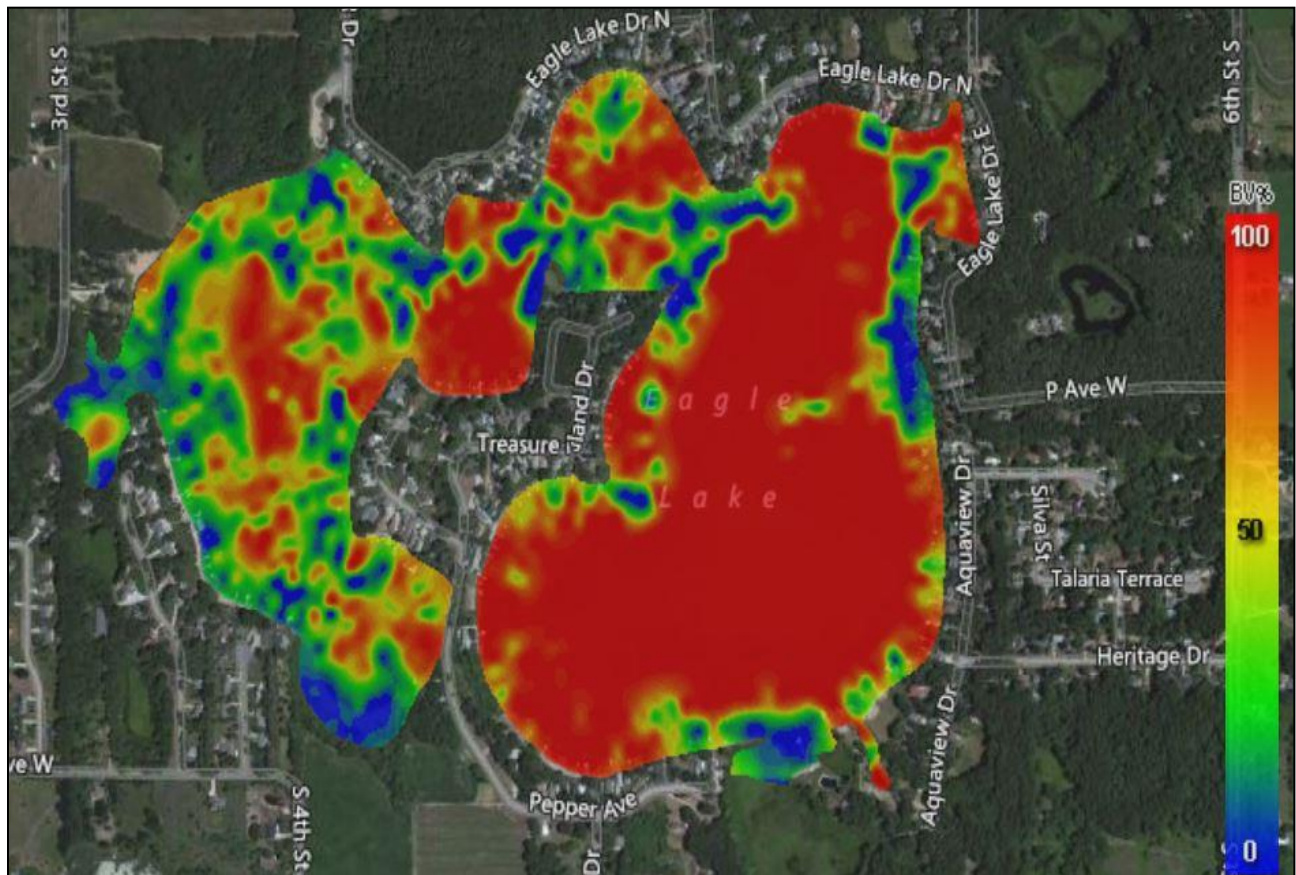
Figure 5. An aquatic vegetation biovolume scan map of Eagle Lake (May 13, 2016, RLS).

Aquatic Vegetation Assessment Site Surveys were conducted on Eagle Lake on May 13, 2016 and again on September 15, 2016. The relative abundance of each aquatic plant species along with the original data sheets and maps can be found in Appendix B. In general, there were 16 native submersed, 4 native floating-leaved, and 5 emergent aquatic plant species found during the survey. A whole lake scan using a Lowrance HDS 8[®] sonar unit with GPS software was used to create an aquatic vegetation biovolume map (Figure 5) of the lake on May 13, 2016 as a baseline. Three invasive species were found and included Eurasian Watermilfoil which occupied approximately 4.2 acres in May, 2016 (Figure 6) and 3.5 acres in late summer of 2016 (Figure 7). Additionally, approximately 117 acres of nuisance Illinois Pondweed (Figure 8) were noted and would make recreation on the lake nearly impossible. Both milfoil and pondweeds were effectively treated in 2016. The entire lake will again be monitored in 2017 to assess any changes in aquatic plant communities. Note that changes in aquatic plant communities may occur naturally annually on inland lakes and changes due to the LFA system require not only reference to changes in relative abundance but also to bio volume.

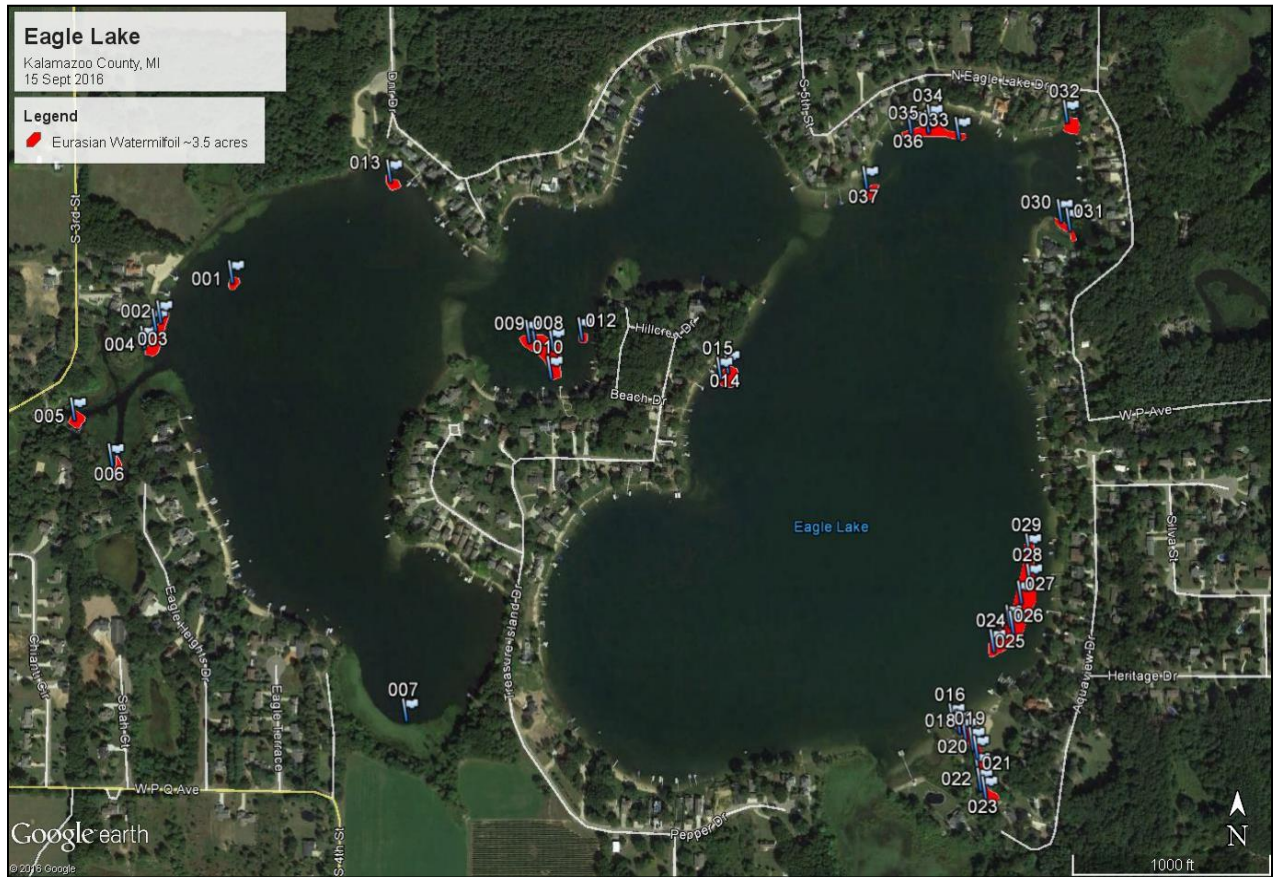
Figure 7. A map of invasive milfoil locations within Eagle Lake (September 15, 2016, RLS).

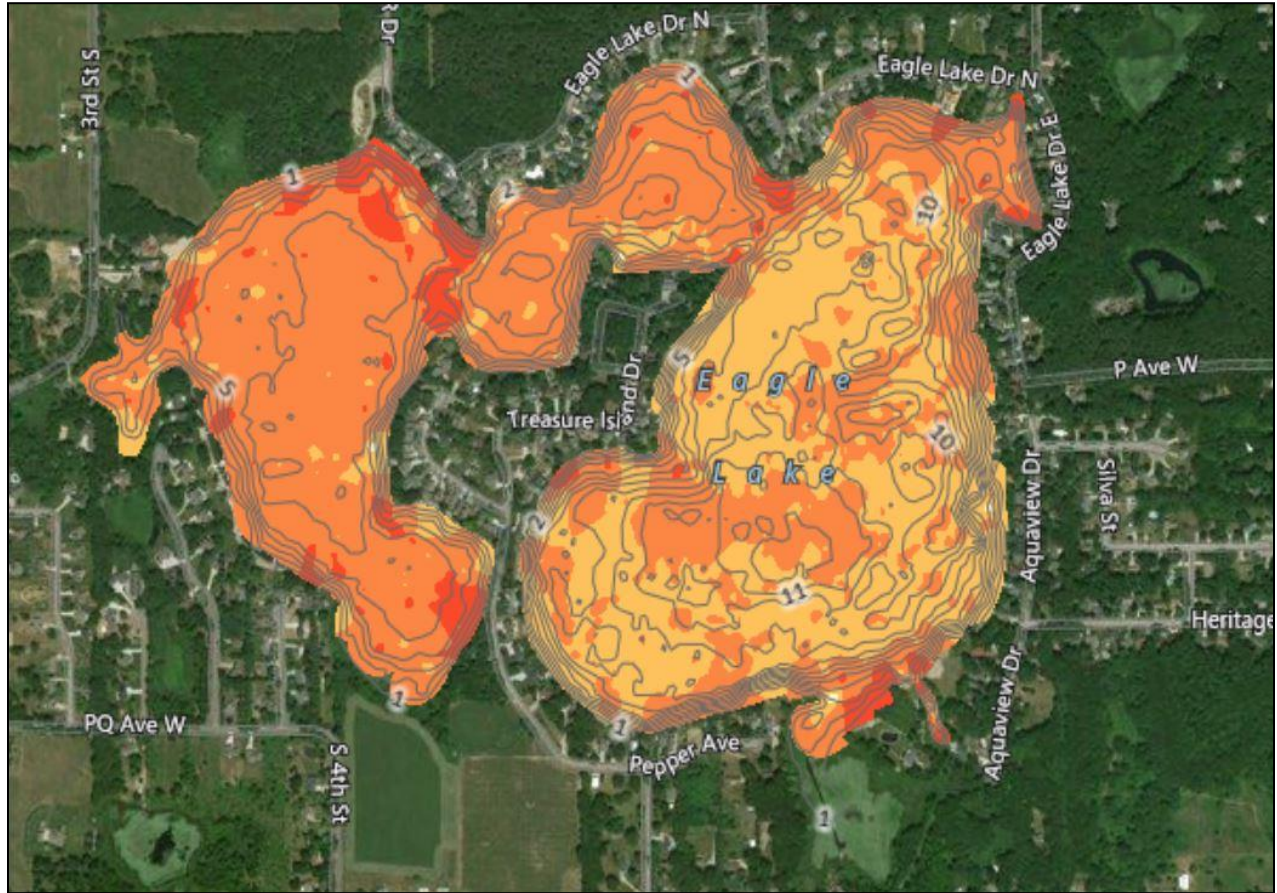
Figure 9. Bottom hardness scan of Eagle Lake (October 25, 2017).

A bottom hardness scan of Eagle Lake was conducted on October 25, 2017 along with the sediment probe data which was collected as baseline data during 2016. Figure 9 below shows the bottom hardness scan map and Table 62 below shows the 2017 bottom muck depth data.

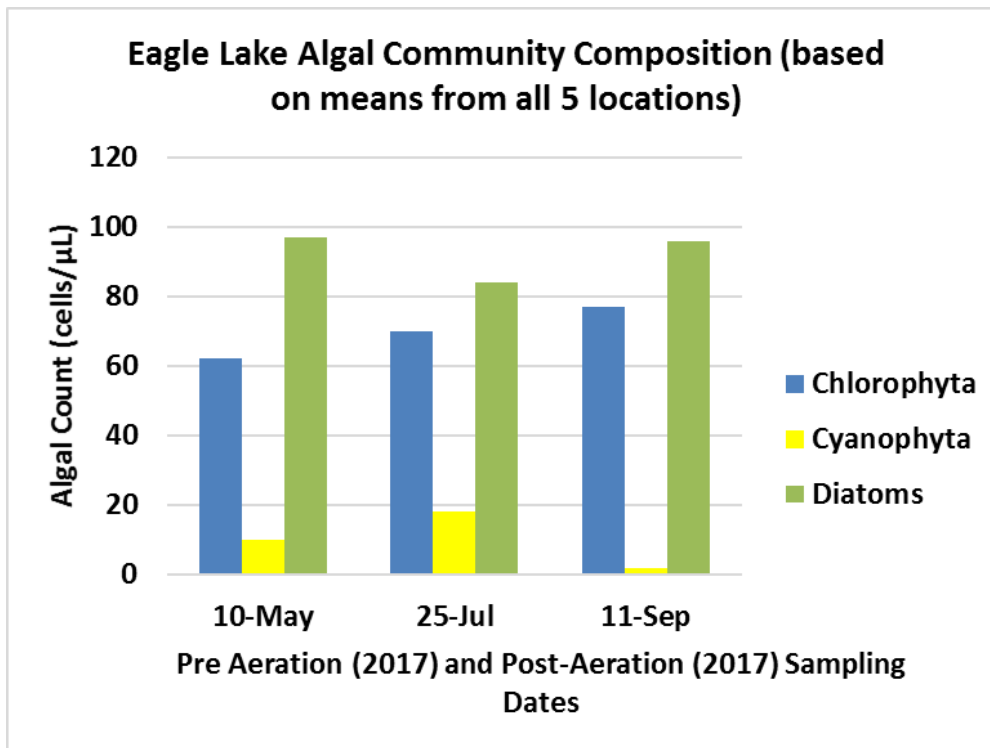
Algal community composition data was also collected in 2017 as in the 2016 baseline. Figure 10 below shows the relative abundance of the key taxa which include the green algae (Chlorophyta), blue-green algae (Cyanophyta), and the diatoms (Basillariophyta). The chlorophyta consisted of genera such as: *Scenedemsus* sp., *Chlorella* sp., *Spirogyra* sp., *Mougeotia* sp., *Pediastrum* sp., and *Cosmarium* sp. The blue-green genera consisted of: *Gleocystis* sp., and *Oscillatoria* sp. The diatoms consisted of: *Navicula* sp., *Synedra* sp., *Cymbella* sp., *Fragillaria* sp., and *Rhoicospenia* sp. These taxa represent a balanced algal community.

Figure 10. Algal community composition in 2017 (pre [May] and post-aeration [July and September]).

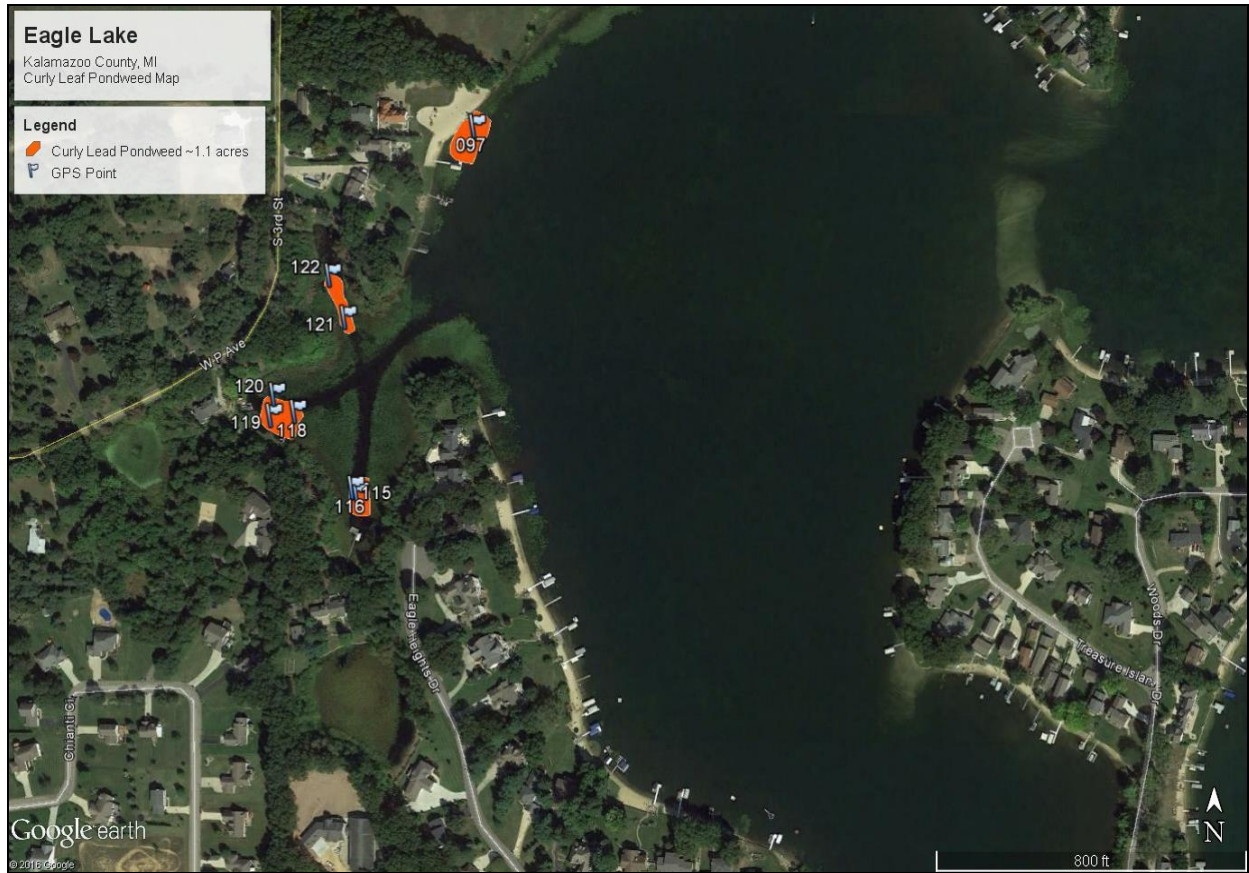
Figure 12. CLP locations in Eagle Lake (May, 2017).

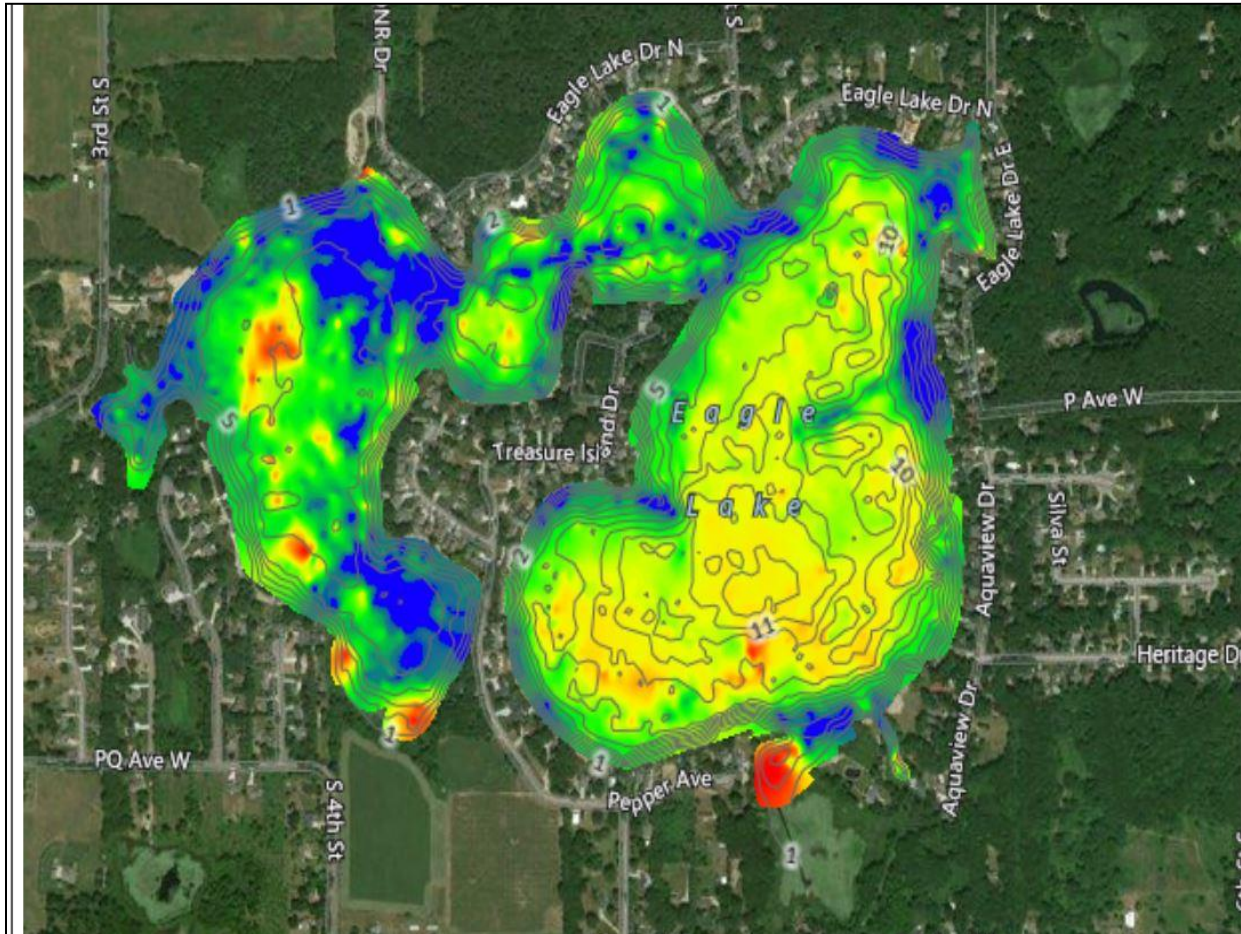
Figure 16. Aquatic vegetation biovolume scan of Eagle Lake (October, 2017). Note: The blue areas represent no vegetation; green represents low-growing vegetation; red represents high-growing vegetation such as the lily pads and pondweeds.

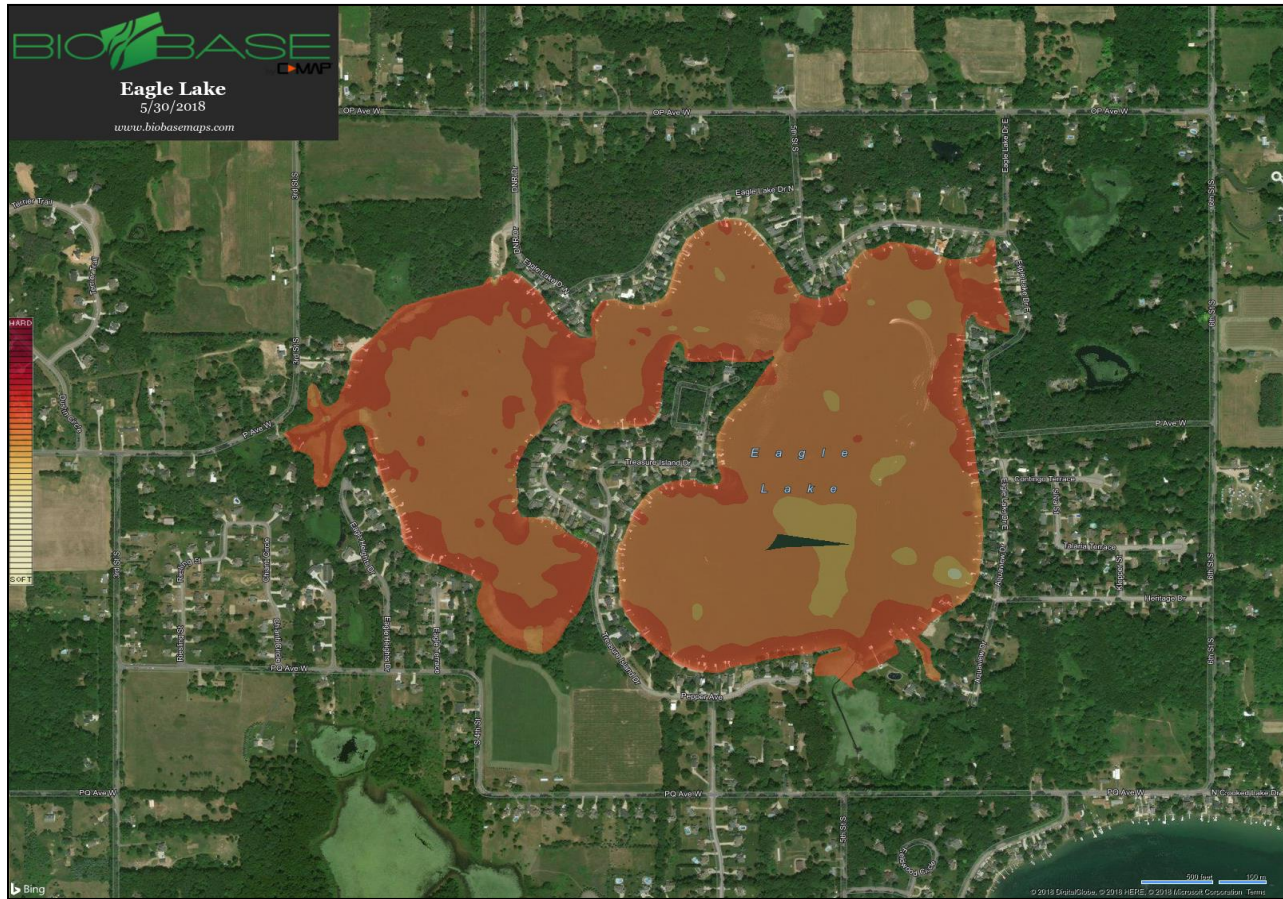
Figure 17. Eagle Lake sediment bottom hardness scan (May 30, 2018).

Sediment probe measurements were not conducted in 2018 due to the extreme flooding that may have deposited sediment loads into the lake. Bioaugmentation was applied to reduce any incoming organic loads and sediment probe measurements will be conducted in 2019 and compared to previous measurements. A whole-lake sediment bottom hardness scan was conducted in 2018 and these values and the corresponding map are shown below.

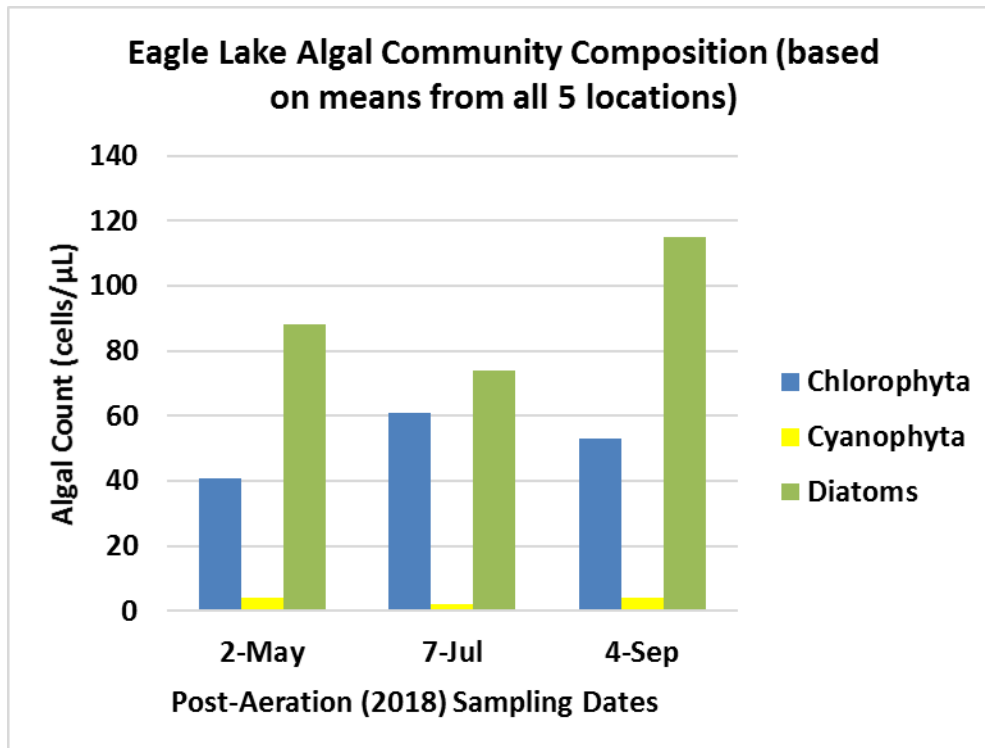
Algal community composition samples were collected during the three 2018 sampling dates. The graph showing the relative abundance of each algal group is shown below in Figure 18. Genera are listed here in the order of most abundant to least abundant. The genera present included the Chlorophyta (green algae): *Scenedesmus* sp., *Chlorella* sp., *Cladophora* sp., *Rhizoclonium* sp., *Mougeotia* sp., *Ulothrix* sp., *Haematococcus* sp., *Pediastrum* sp., and *Spirogyra* sp., the Cyanophyta (blue-green algae): *Oscillatoria* sp.; the Bascillariophyta (diatoms): *Navicula* sp., *Synedra* sp., *Fragilaria* sp., and *Rhoicosphenia* sp.

Figure 18. Algal community composition in Eagle Lake in 2018.

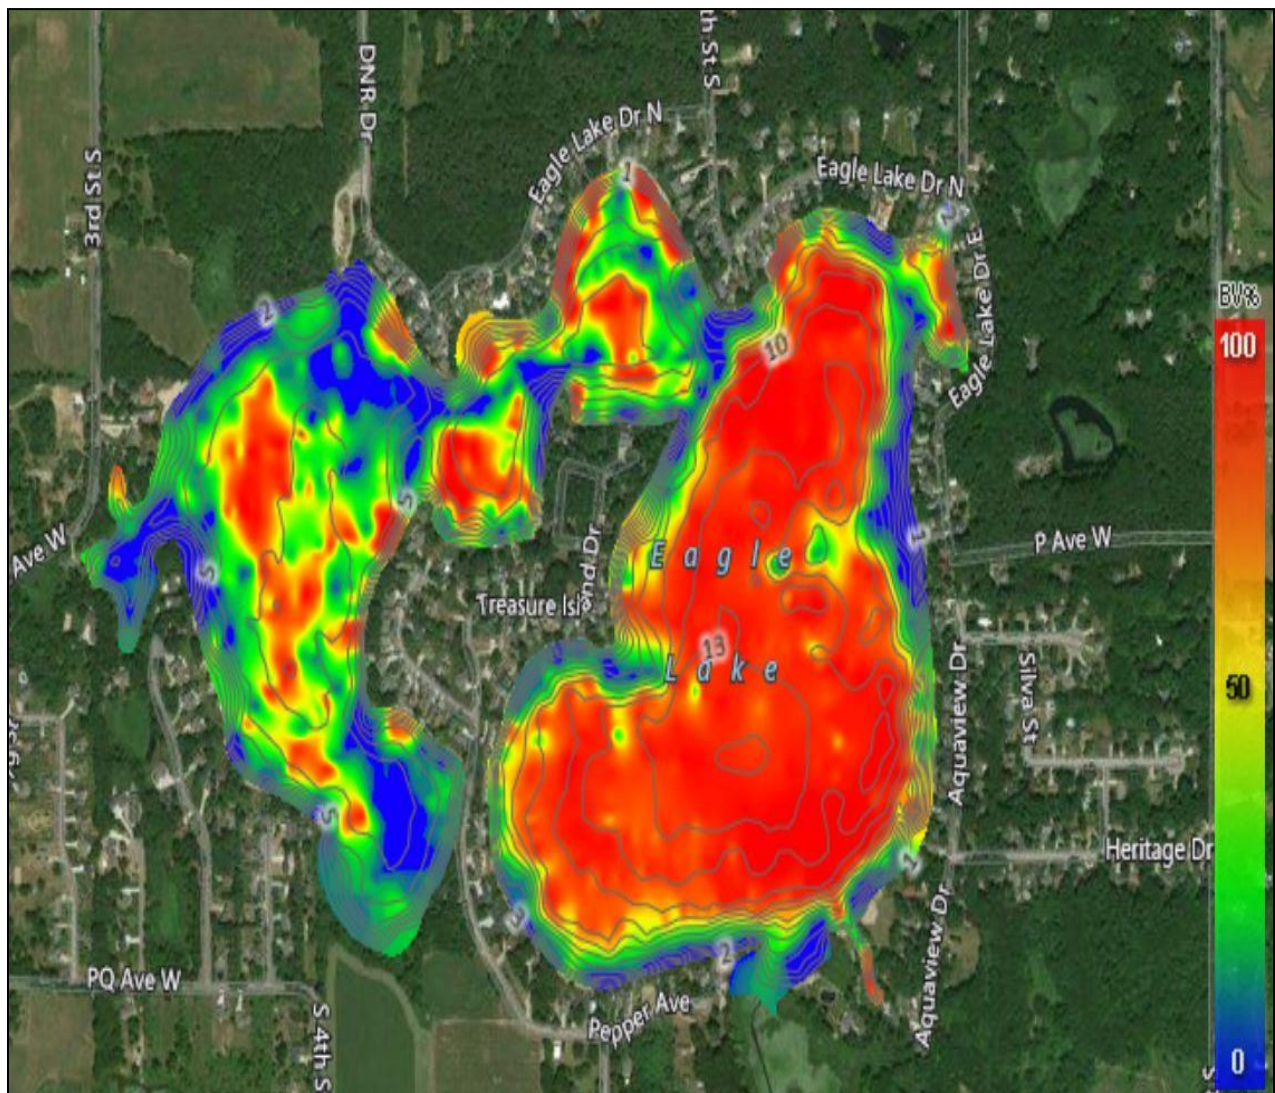
Figure 19. 2018 Eagle Lake aquatic vegetation biovolume map (May 30, 2018).

A whole lake aquatic vegetation biovolume scan was conducted on Eagle Lake on May 30, 2018. In addition, there were survey maps prepared for weed treatments from surveys on May 30, 2018, July 7, 2018, and August 2, 2018. The data comparisons of biovolume and corresponding map are shown below.

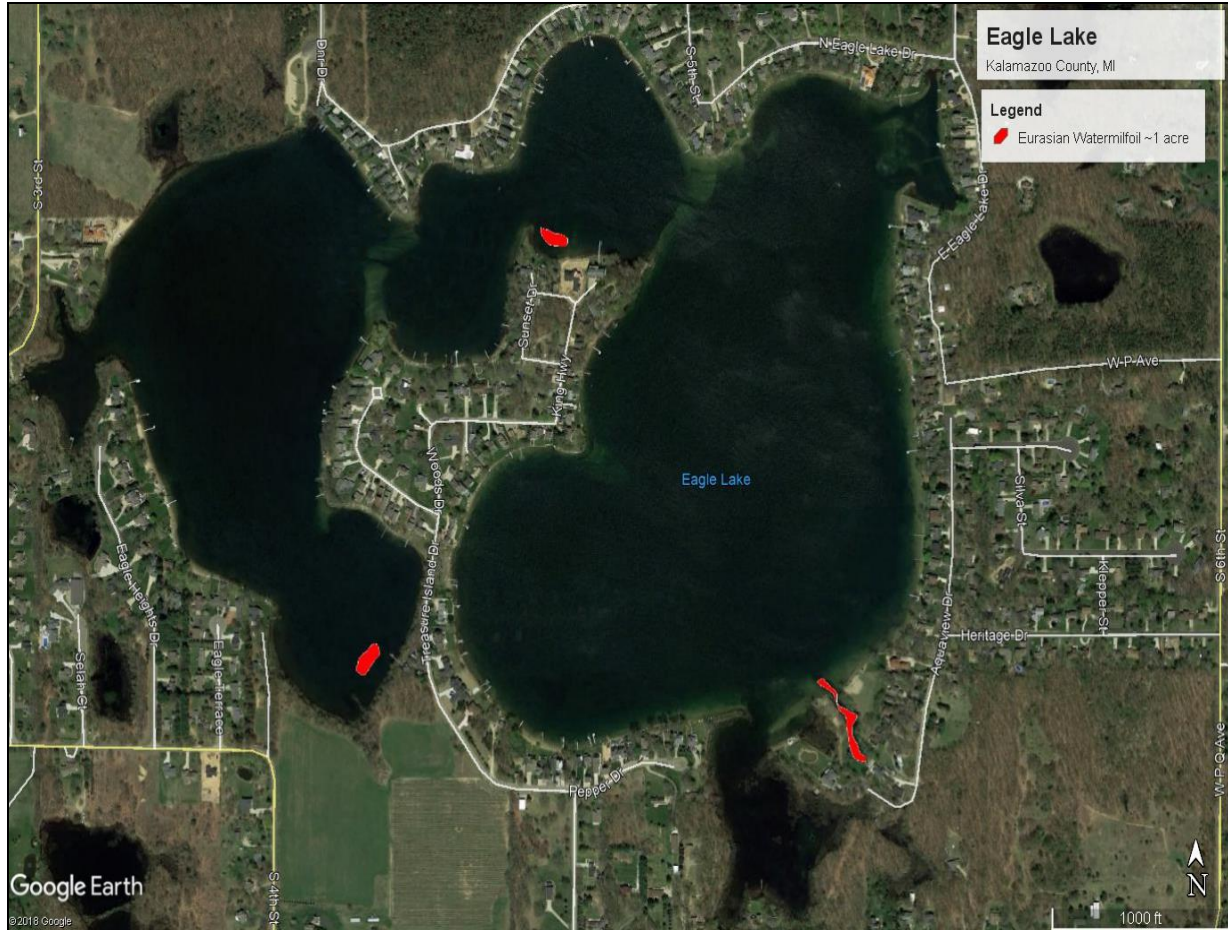
Figure 21. Distribution of EWM in Eagle Lake (May 30, 2018).

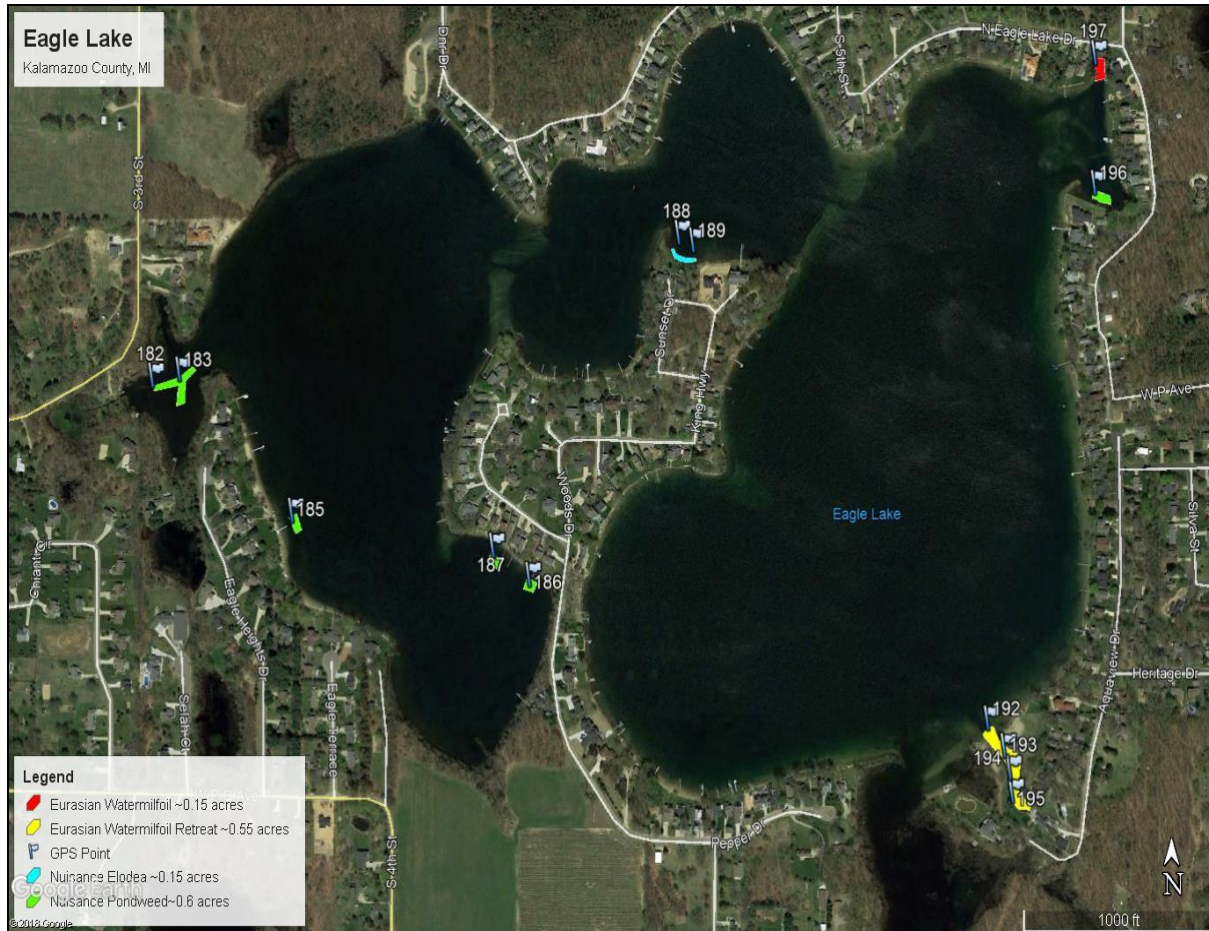
Figure 22. Late season EWM and nuisance plant growth in Eagle Lake (August 2, 2018).
